**FOURTH FIVE-YEAR REVIEW REPORT FOR
WYCKOFF/EAGLE HARBOR SUPERFUND SITE
KITSAP COUNTY, WASHINGTON**

**U.S. Army Corps of Engineers
Seattle District
Seattle, Washington**

**U.S. Environmental Protection Agency
Region 10
Seattle, Washington**

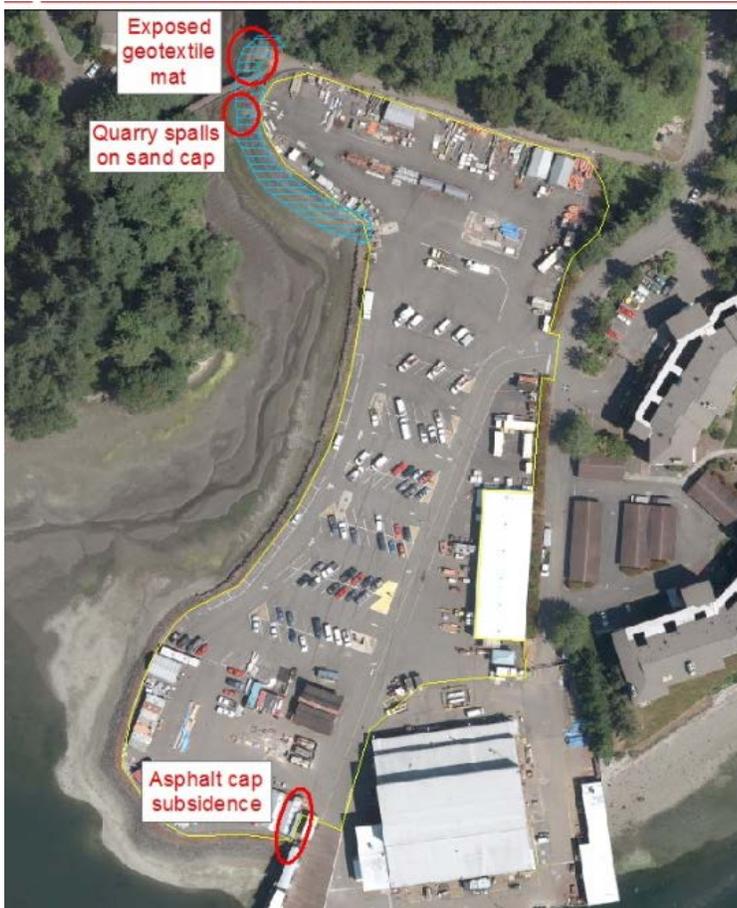
Figure 4. Location of Persistent Issues at OU-3

One portion of the asphalt cap has had continued subsidence issues. In 1999, a subsidence was discovered on the southern shoreline adjacent to Pier A (Figure 4) and was repaired with an asphalt patch. An investigation concluded that the subsidence may have been caused either by displacement of fines through tidal action or by differential settlement of the berm material. Additional repairs were made in 2006 and 2009. In 2013, a hole 2 feet in diameter and 2 feet deep formed (Figure 5). A more permanent repair was designed. The August 2013 repair included the installation of concrete locks along the under pier edge to prevent sloughing of fill material. In May 2014, under pier elevation markers were installed to monitor scour and settlement of material near this subsidence area. These markers are now monitored during annual site inspections. As of 2016, no significant erosion has been observed at these markers.

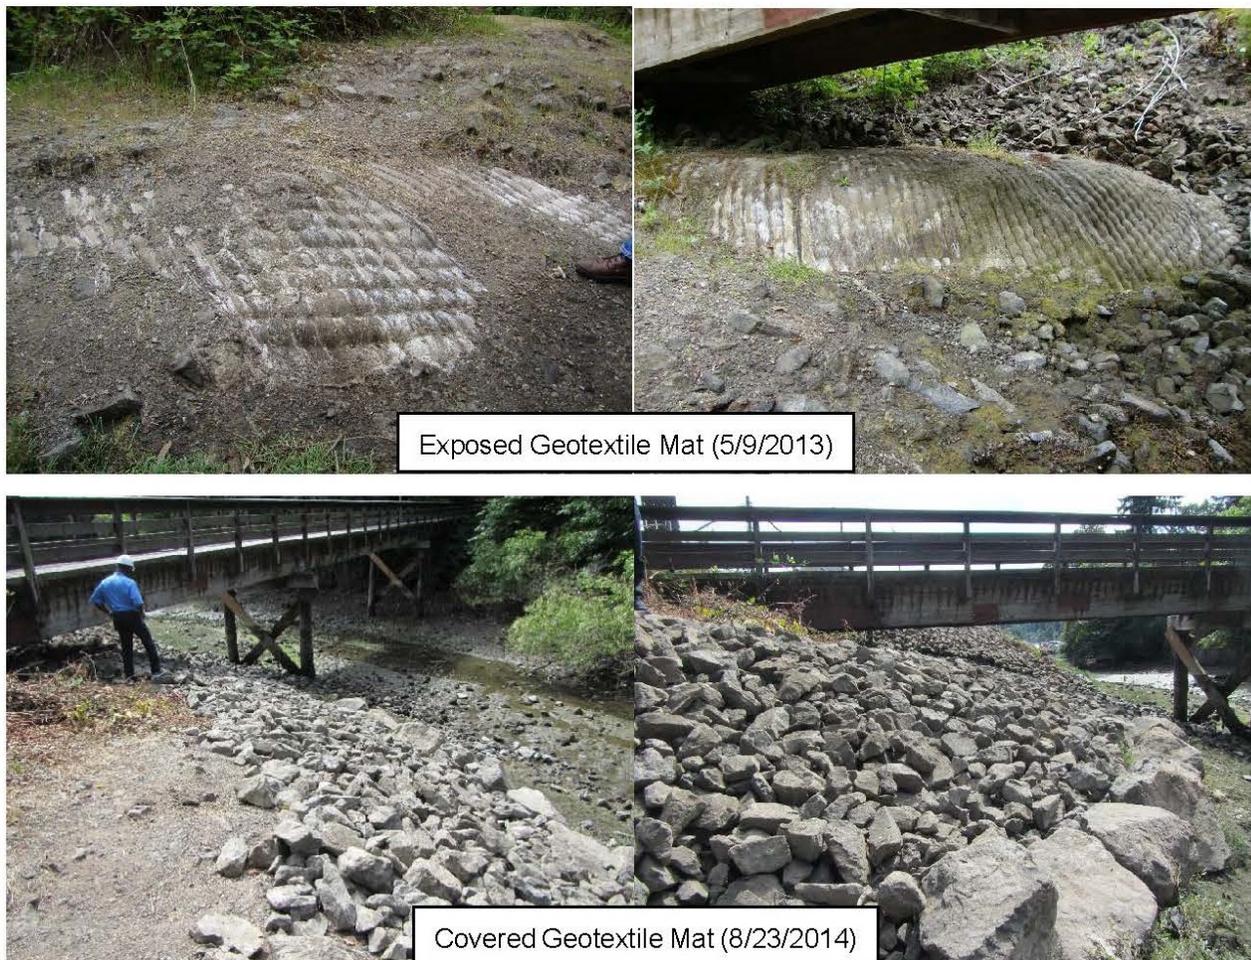
Figure 6. 2013 Geotextile Mat Exposure and Repair, OU-3

A portion of the shoreline geotextile mat north of and under the footbridge (Figure 4) has continued to be exposed (approximately 25 ft²), and began to show signs of deterioration and cracking in 2012. Repairs were made in August 2013 by placing additional quarry spall and boulders (Figure 6).

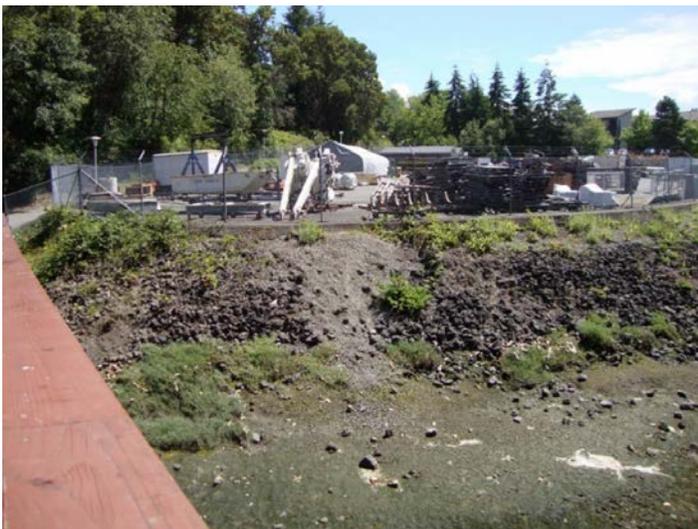
Figure 7. Quarry Spalls on Sand Cap, OU-3

In 2016 quarry spalls were observed on the sand cap along the rockery south of the footbridge (Figure 7 and Figure 4). These spalls appeared to have either fallen or been thrown down the slope. It did not appear to the inspectors that this would impact the integrity of the rockery.

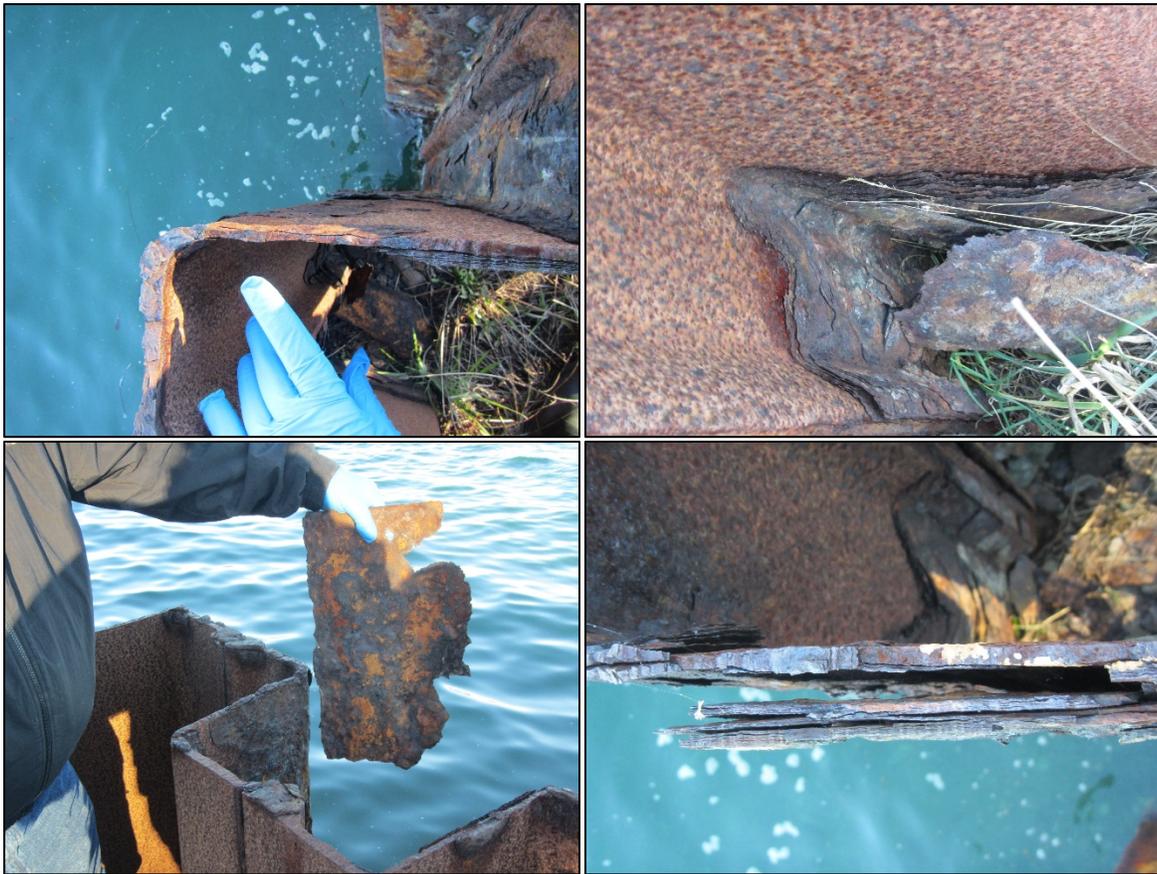
Figure 8. OU-2/OU-4 Sheet Pile Wall Corrosion

The other aspects of OU-2/OU-4 remedy were in good condition. Although not operational at the time, the extraction wells appeared to be in good condition; however, ice had pooled at the bottom of the containment area posing a safety hazard for personnel maintaining the extraction system. Vegetation around the site was significantly overgrown. Pathways between the extraction wells were cut into the vegetation, but general vegetation cut-back should occur. The tank area and treatment system building were in excellent condition; well organized and kept clean.

2&4	Corrosion of the outer sheet pile wall.	Evaluate current wall thickness and provide corrosion protection of the sheet pile wall.	Ongoing	Evaluations of the sheet pile wall were completed in 2013, 2016, and 2017. Monthly visual inspections are scheduled, and reports are issued which indicate increasing corrosion. Corrosion protection has not been implemented. The Proposed Plan issued in 2016 provides a plan to address the sheet pile wall.	Ongoing.

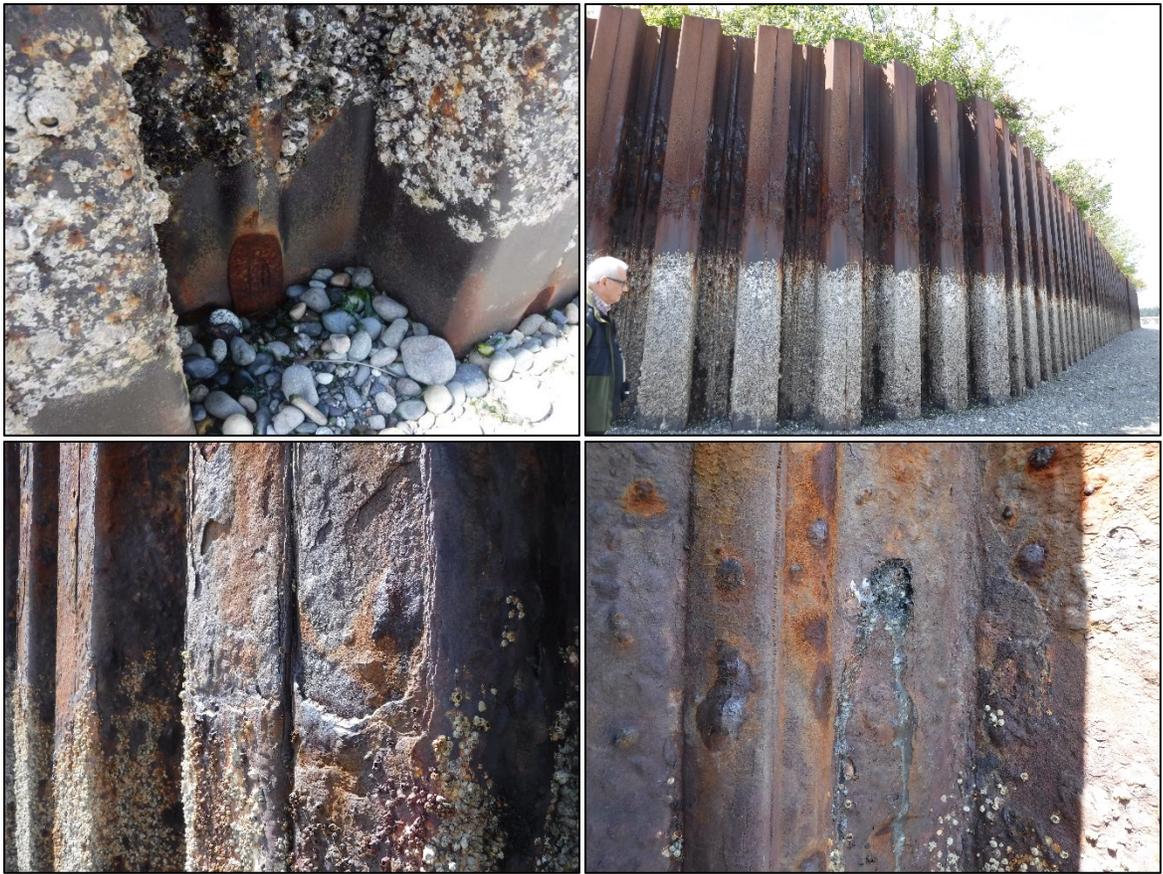
Figure 9. OU-2/OU-4 Outer Sheet Pile Wall Corrosion

While testing the thickness of the wall by tapping a rock along the surface, a section about 4 inches in diameter broke off of the sheet pile wall. Soil and water began leaking out of the hole (Figure 9). Subsequent site visits attempted unsuccessfully to find the location of the break for verification. The initial break from tapping may potentially have been blister in the exfoliating layers of the wall that contained soil and water. The engineers noted that the sheet pile wall would not likely fail by collapsing, but that holes, like the one created, would become more common.

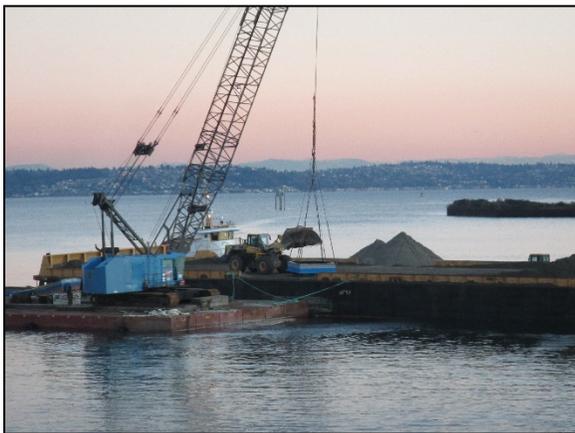
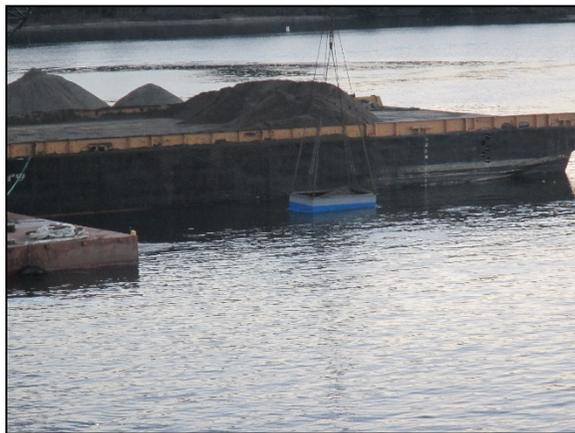
Photo 5. Subtidal cap repair along ferry route

In early 2017, repairs were made to the subtidal cap in the area where previous studies revealed ferry propeller wash had displaced portions of the existing Phase 1 cap, along the ferry lane. To restore necessary isolation, one foot of clean sand was added over the exposed area (9.3 acres). The high impact center of the ferry lane (3.5 acres) also received an additional 2-foot thick layer of 6 inch quarry rock for armoring. Repairs were completed on February 23, 2017. (FPM-CTI, 2017)

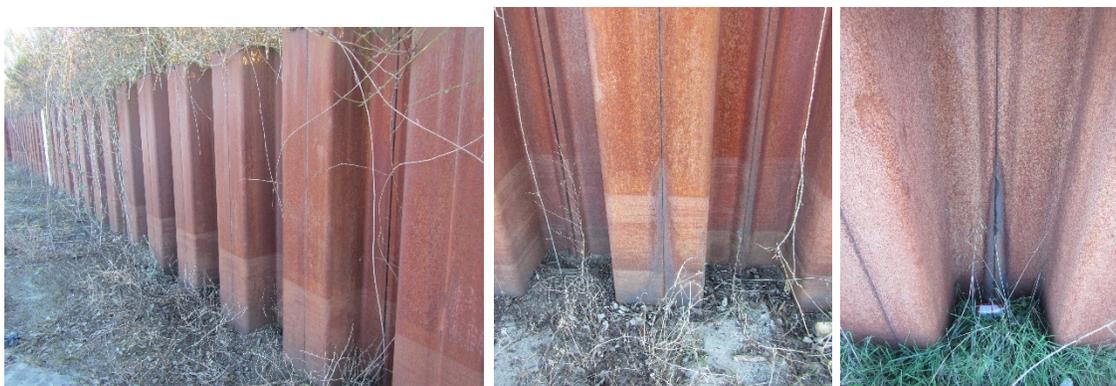
Photo 3. Outer edge of western sheet pile wall; some leakage stains observed.

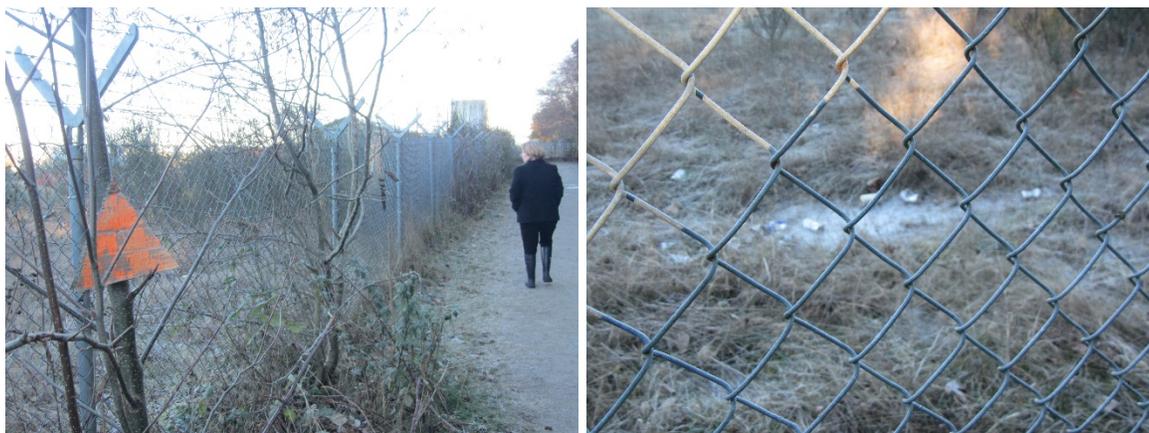
Photo 5. Southern fence along walking path. Some trash observed within fenceline.

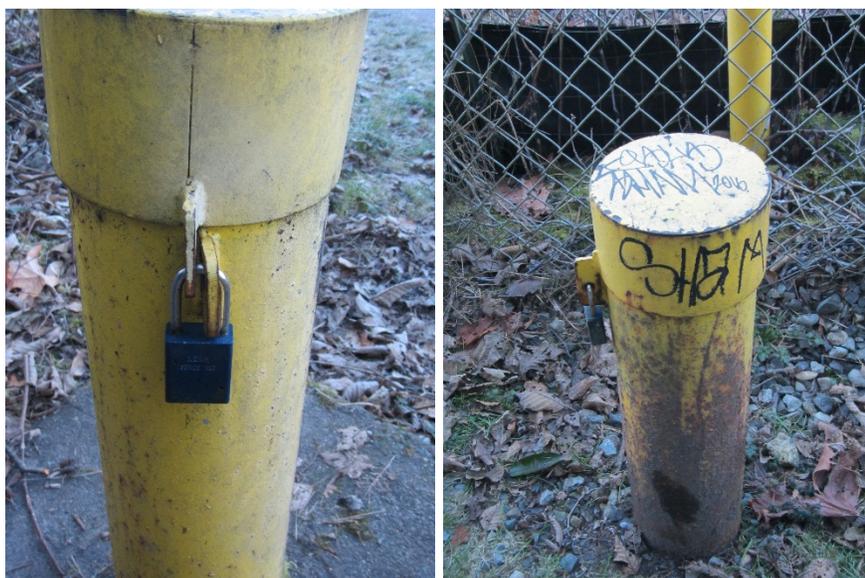
Photo 6. Groundwater monitoring wells. Graffiti observed.

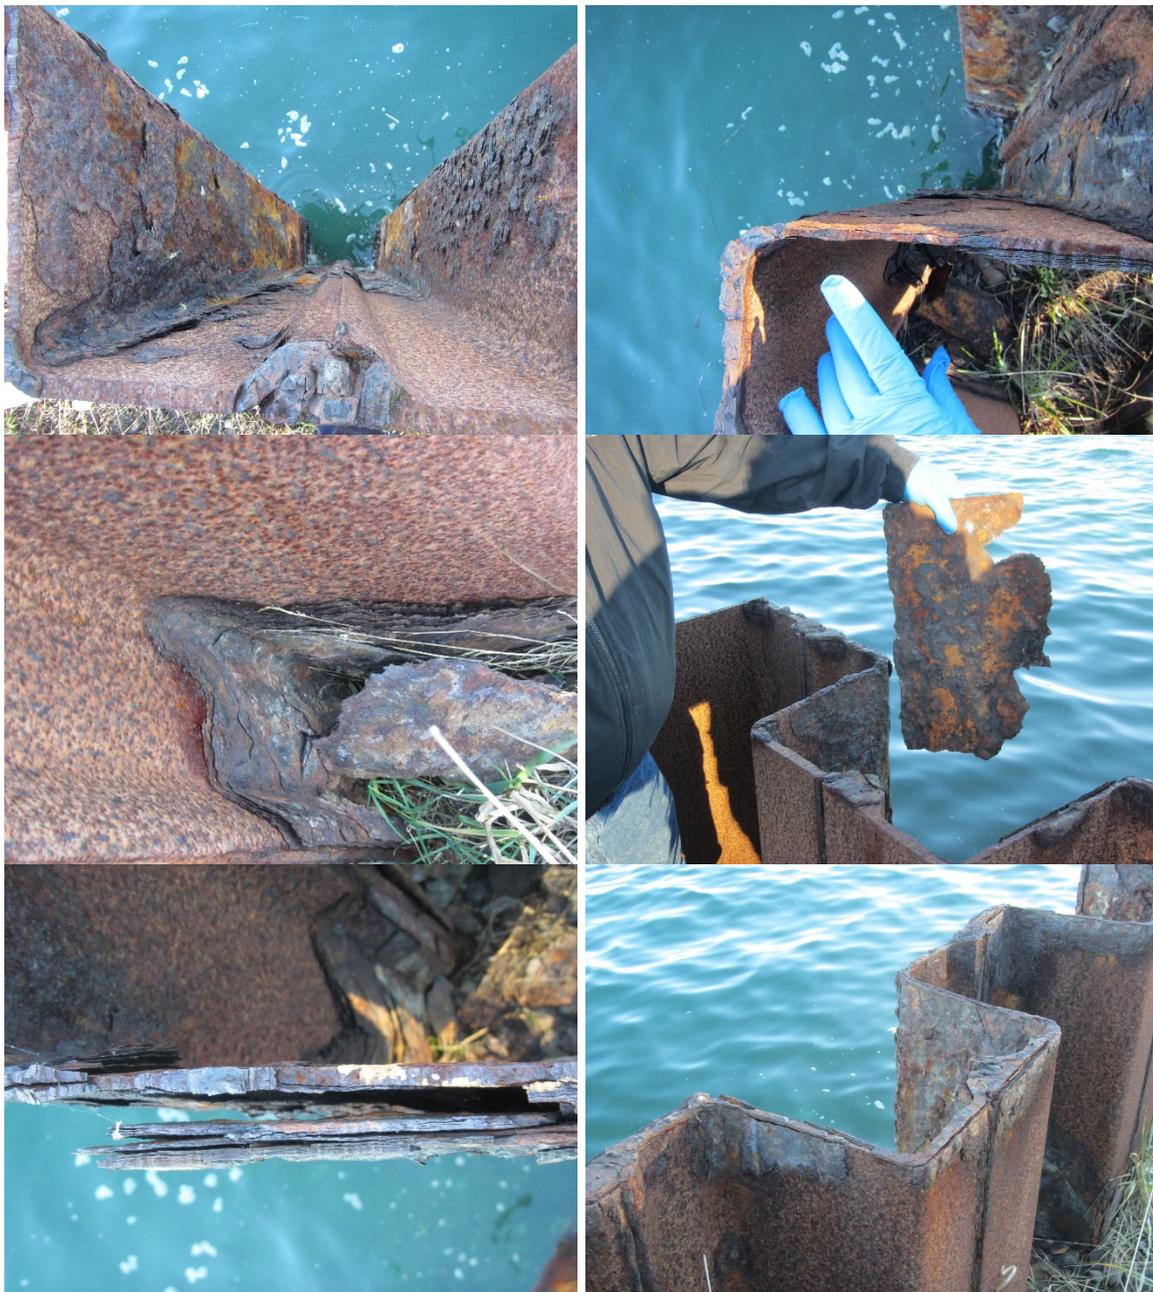
Photo 13. Degraded eastern sheet pile wall.

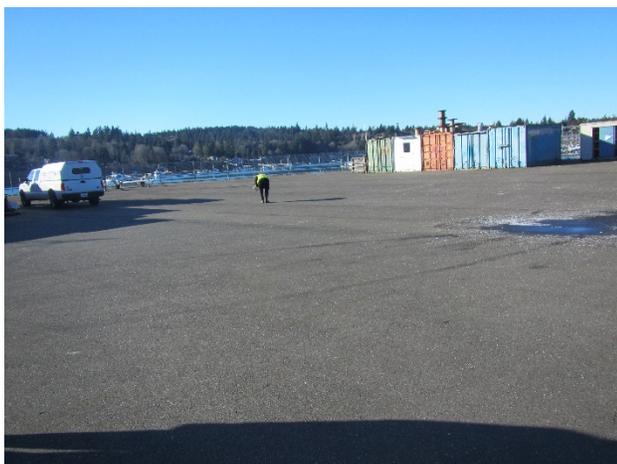
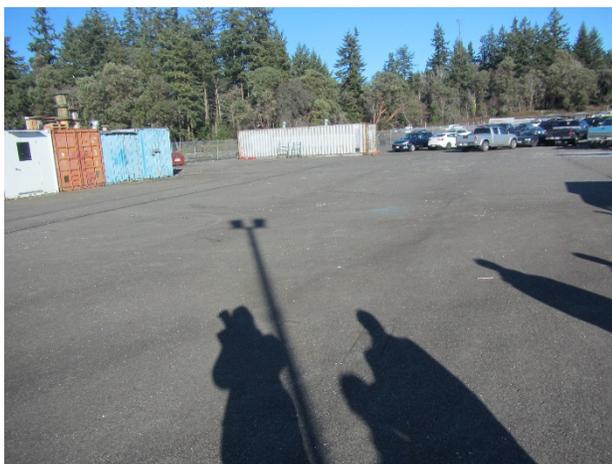
Photo 1. Main cap area. Repaired cracks seen as darker lines.

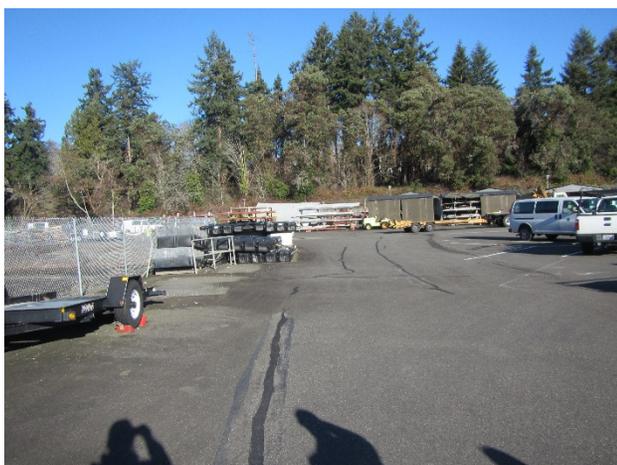
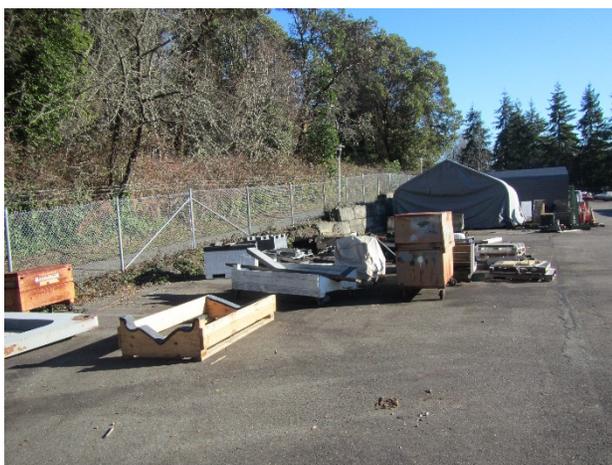
Photo 2. Uncovered storage areas. Repaired cracks seen as darker lines.

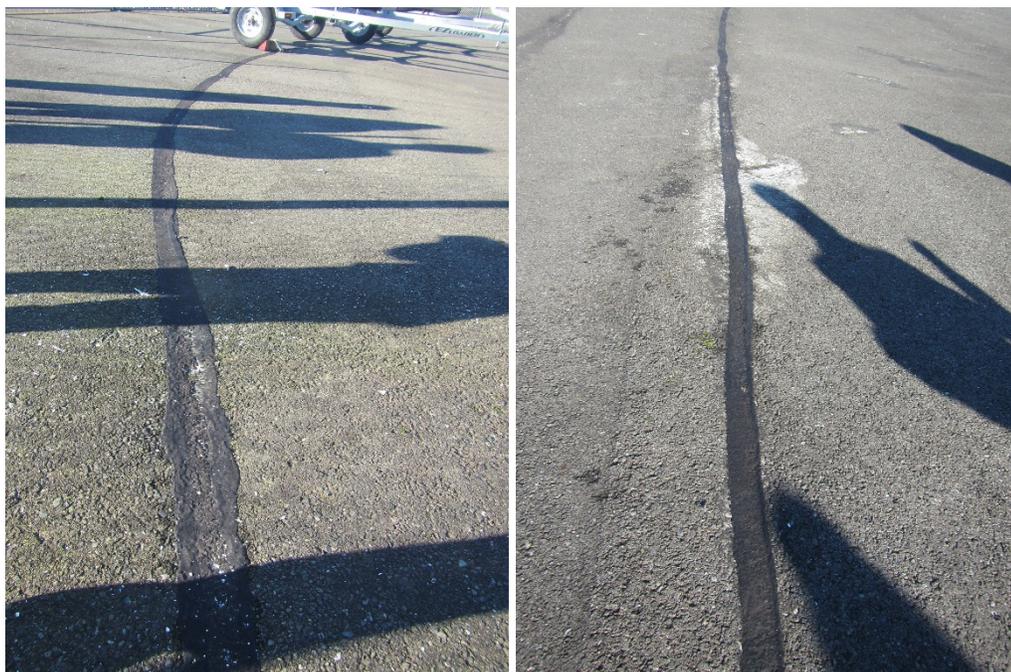
Cracking on the asphalt surface is a continuing problem at OU-3. Several long cracks along the construction joints were originally discovered in 2009 and were sealed with asphalt the same year. Additional repairs were subsequently made in 2011 and 2012. In 2011 a pavement engineer evaluated the asphalt cap surface and found it in overall good structural condition, though showing signs of aging. In 2013 the cracks were resealed using a new method. The cap condition was again evaluated in 2016 and 2017 and found to be in sound structural condition despite the signs of aging. It was decided to continue monitoring semiannually to determine when a full asphalt overlay is needed.

Photo 4. Repaired cracks.

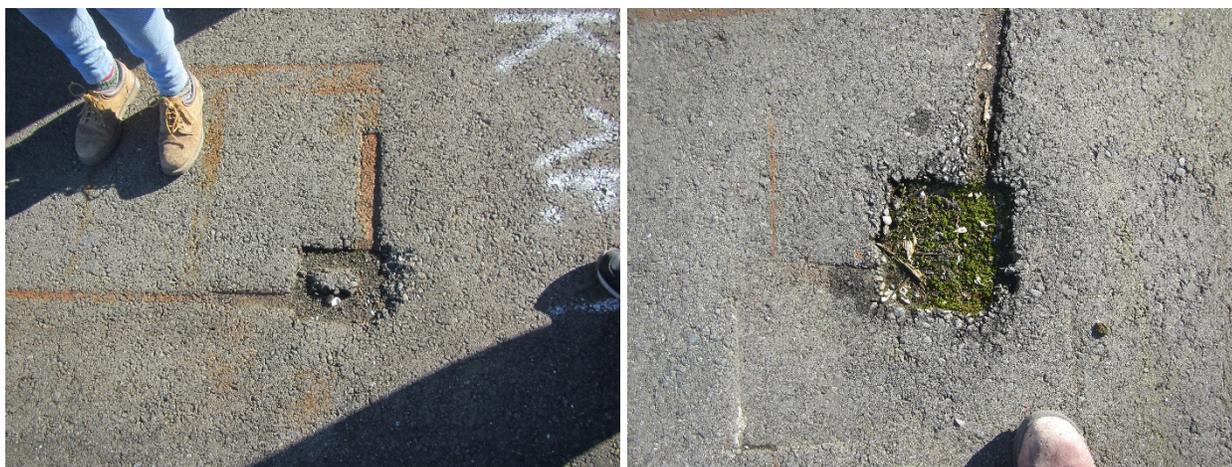
Photo 5. Dents caused by storage container feet. Photo on right was potentially a hole.

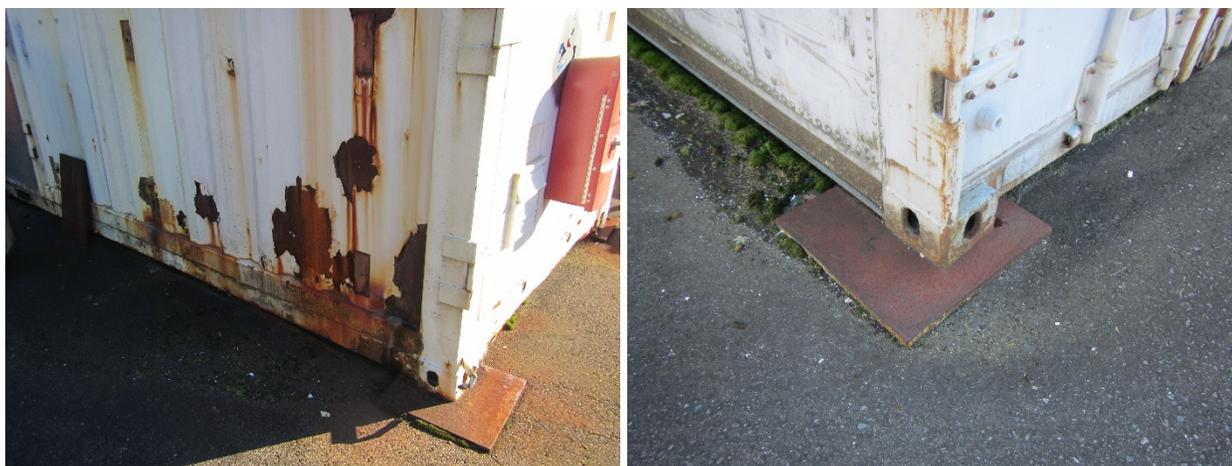
Photo 6. Plates placed under recent storage containers to prevent denting. Also note rusting on containers.

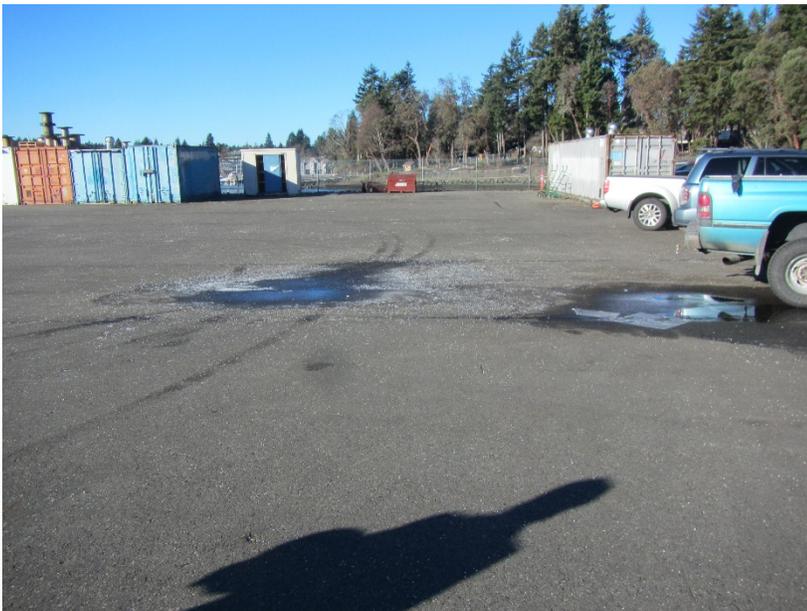
Photo 7. Ponding area on cap. Ice was present; white material is deicing salt.
